BioSTONE REPAIR

NATURAL HYDRAULIC LIME-BASED MORTAR
WITH LOW ELASTIC MODULUS
AND IMPROVED ADHESION FOR REPAIRING STONEMWORK

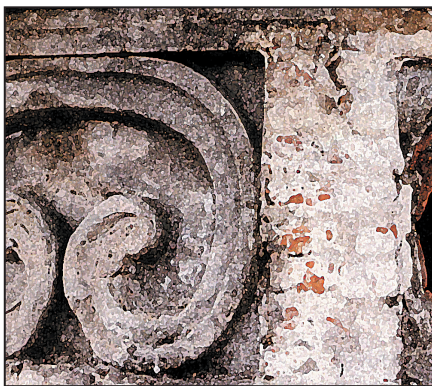
RECONSTRUCTING STONE DETAILS

In the various restoration operations, problems often occur of repairing or reconstructing panels, cornices, doorways in stone of various kinds such as tuff, marble, grey Italian sandstone etc.

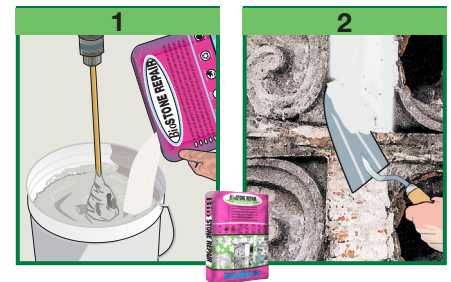
BioSTONE REPAIR must be mixed with clean water only. Use a drill at low speed with a suitable paddle (1). Avoid mixing for longer than the time required for obtaining a uniform paste free of lumps.

The product can be applied with a stainless float or trowel (2) without the need for formwork as the product is highly thixotropic.
